Quality in Mammography

Julian Marshall

Chief Marketing Officer
Volpara Solutions, Inc.

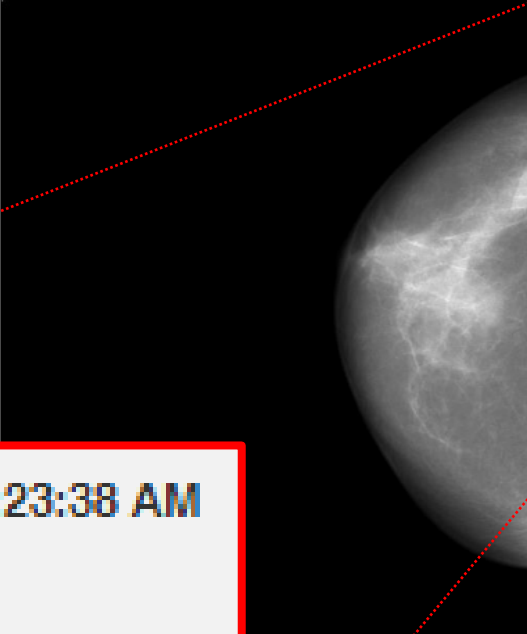
Image Result
Anonymized Patient ID: 2027

Performed on 7/23/2016 10:23:38 AM
Performed by Operator-1
Quality Score: Inadequate
Nipple is not in profile.

Performed on 7/23/2016 10:23:38 AM
Performed by Operator-1
Quality Score: Inadequate
Nipple is not in profile.
Nipple to chestwall: 65.5 mm
Breast Density: 8.8 %
Breast Volume: 318.3 cm³
Breast Thickness: 43.7 mm
Compression Pressure: 34.2 kPa
Compression Force: 160 N
Volpara Dose: 1.2 mGy
Tube Voltage: 28 kVp
HVL: 0.4 mm
Exposure: 54 mAs
Filter Material: Rhodium
Anode Target Material: Rhodium
